#06-04

4L60E/4L80E

Repeat Clutch and/or Band Burn-Up

(1996 Models with VCM ONLY)

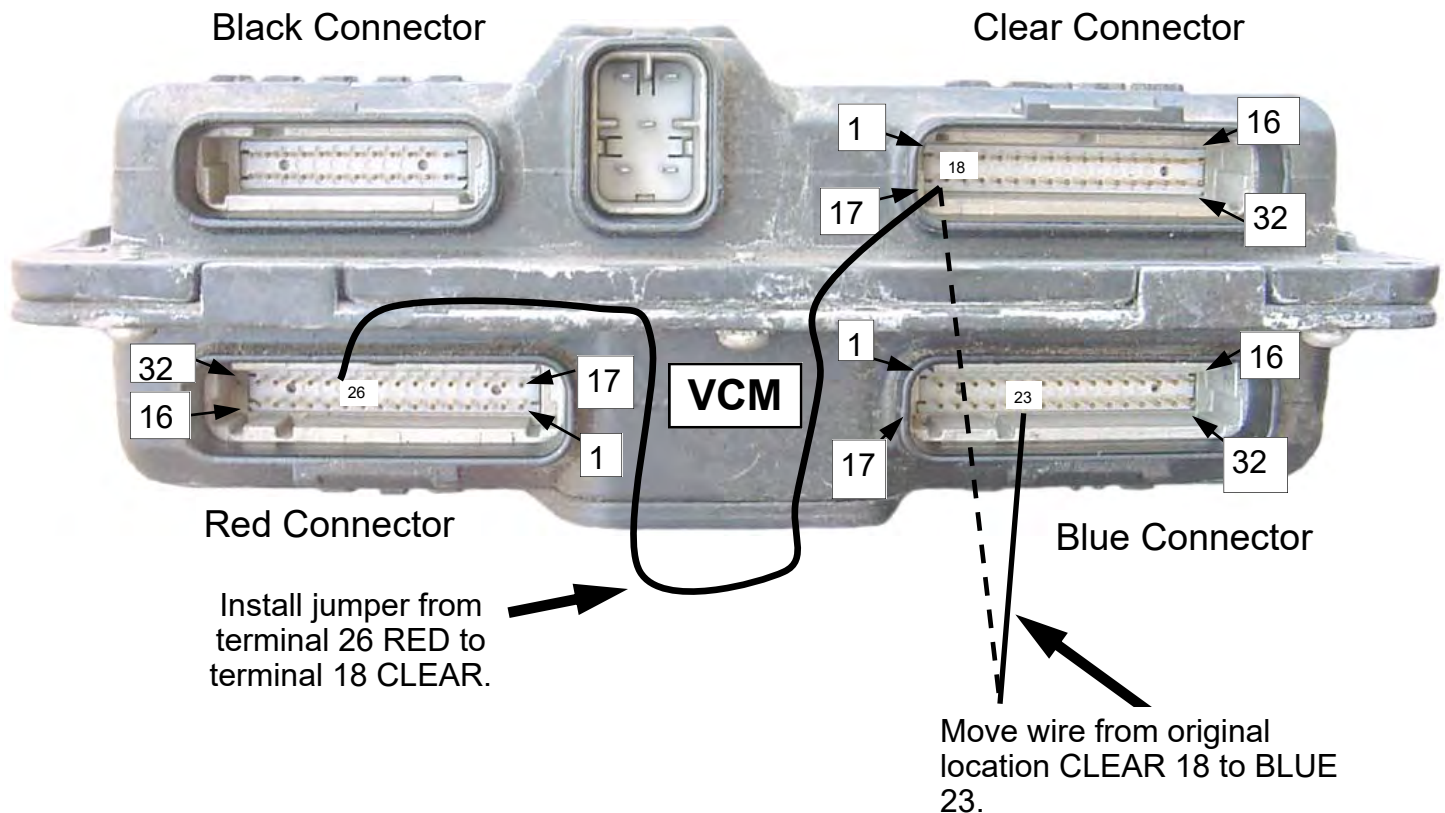
Repeat friction failures on early 1996 model 4L60E (and 4L80E's) can result from an intermittent POOR or NO LINE RISE condition. The cause is commonly due to a poor electrical connection inside the VCM ONLY on vehicles equipped with a Vehicle Control Module (VCM).

Find VCM under hood. Look for a wire in cavity 23 of the BLUE connector.

HAS NO wire in cavity 23 of the BLUE connector = **NEEDS** Update

HAS wire in cavity 23 of the BLUE connector = Already Updated – (It's OK)

Jumper Wire Update Instructions

Step 1 – Move the original wire FROM terminal 18 of the clear connector to terminal 23 of the blue connector. (You have to poke new holes thru rubber boots to get wires into connector).

Step 2 – Install jumper wire from terminal 26 of RED connector to terminal 18 of the clear connector.
