# 4L80E *2nd Printing*

## ***Before & After Service Complaints***

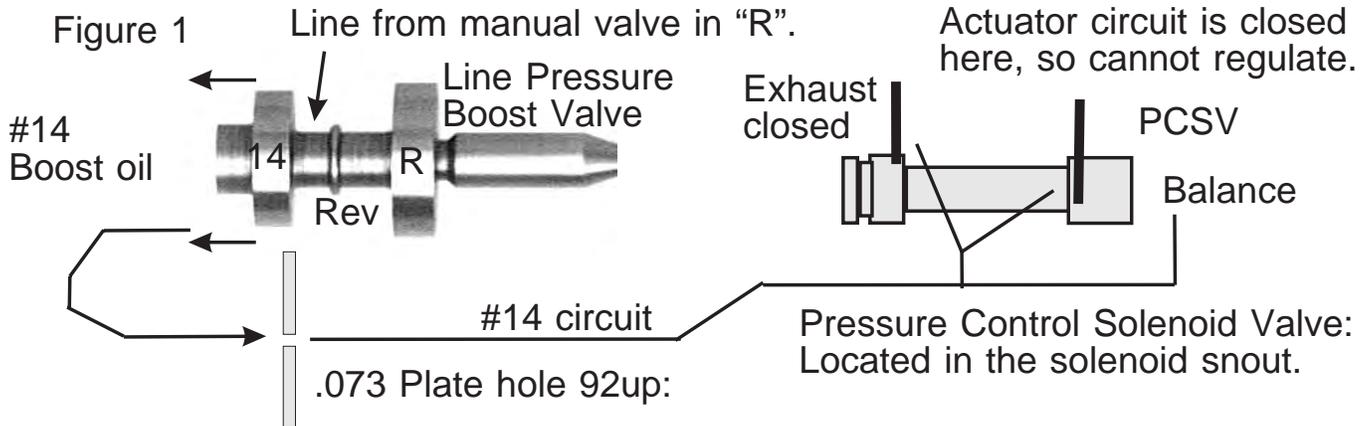
**Fig 1.** Stuck pressure control solenoid valve [located in solenoid]. In forward ranges low pressure results. **In reverse 600-800 psi is common.** Immediate failure due to case, direct clutch drum or piston breakage.

a. In reverse line pressure goes to the rev land of the pressure boost valve. Line flows past the clearance of #14 land into the #14 circuit, through #14 orifice in plate [92up] and is then regulated by the EPC. When EPC is **stuck** in position shown it is **unable** to regulate or exhaust #14 circuit.

This problem can happen at low or high mileage. It is aggravated by the disintegration of solenoid filter and/or metal particle contamination.

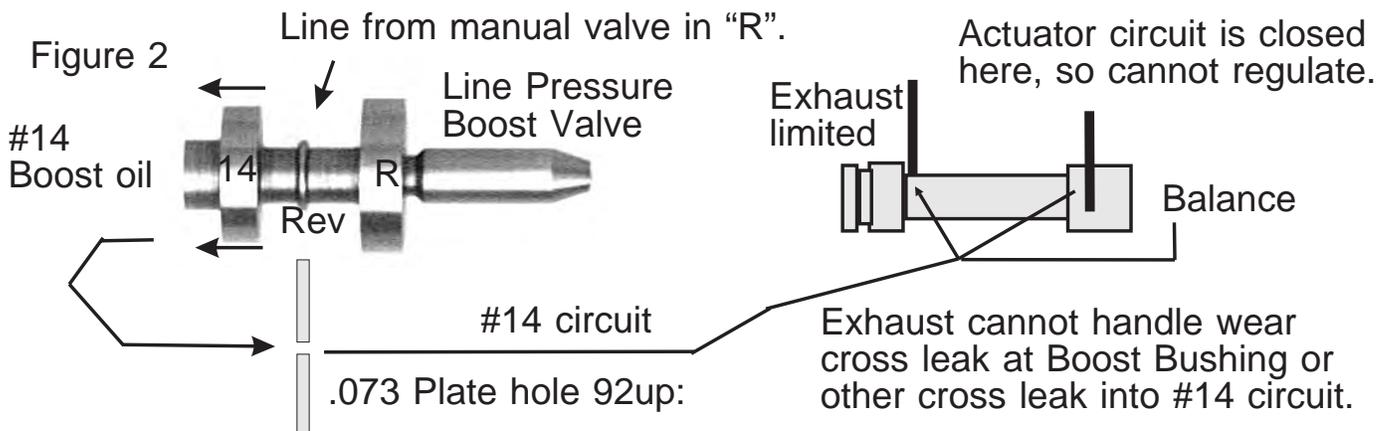
**Fig 2.** In reverse oil leaks into the line boost circuit [#14] in excess of the exhaust capability of the Pressure Control Solenoid Valve Assembly.

In reverse, pressure goes to rev land of the pressure boost valve and flows past clearance of #14 land to #14 circuit, thru #14 orifice in plate [92up] and SHOULD then be regulated by the EPC. The EPC is barely able to exhaust cross flow leaks **without** any boost bushing **wear**, and is **unable** to exhaust or **regulate** excess flow caused by boost bushing wear and/or cross leaks—ANYWHERE—into the #14 circuit. **600-800 psi is not uncommon.**

Replacing the boost valve and bushing or grinding boost valve stem shorter to allow valve to function in new area of bushing may reduce high pressure danger short, but not long term and doesn't correct #1 cause above.

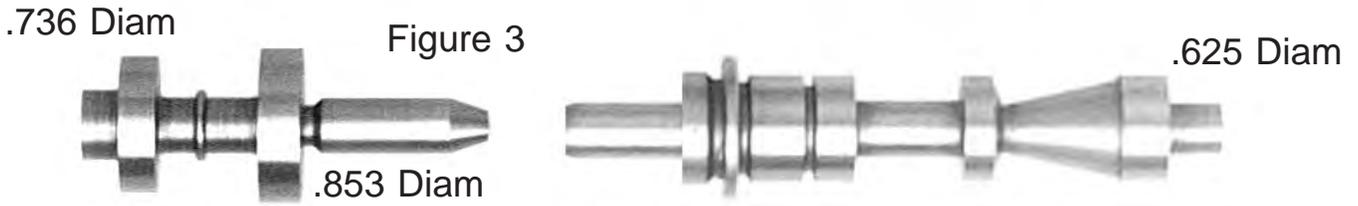
**Fig 3.** Since the diameter of the boost valve [.736] is larger than the balance end of PR valve [.625], a lack of #14 oil regulation results in unlimited pressure and case, direct drum, direct piston or valve body breakage.

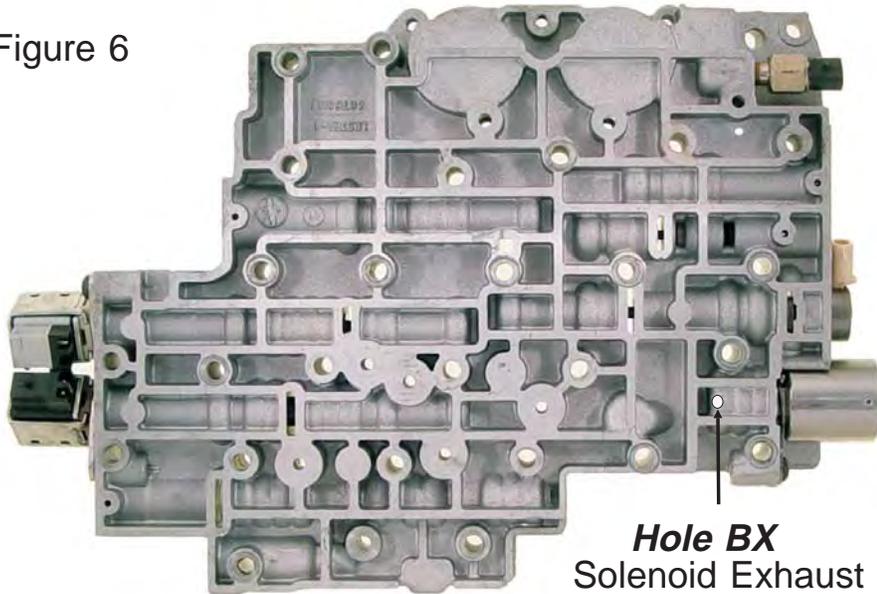
Figure 6

**Fig 6.** There are several case, gasket, solenoid and plate combinations that will cause no line rise in forward ranges and/or max line in forward, and unlimited pressure in reverse.

1st design sol will cause all time high line and breakage.

Problem here occurs when plate or VB is swapped or replacement plate installed.

**The bottom line is this: Never re-install 1st design [shiny] solenoid.**

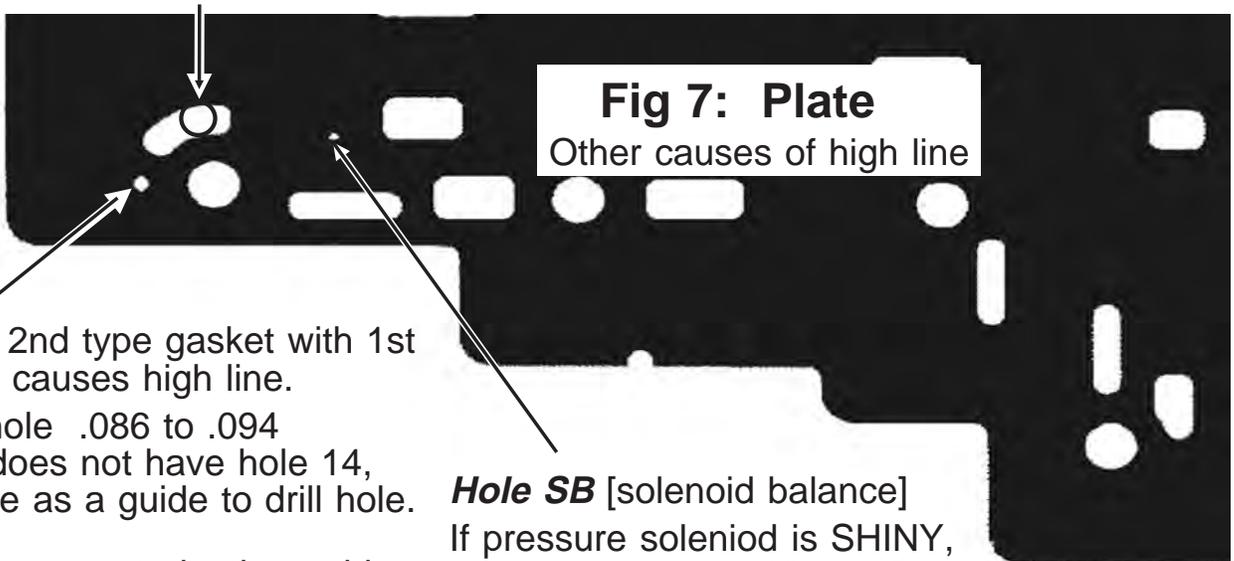
**Hole 14:** 2nd type gasket with 1st type plate causes high line.

Drill this hole .086 to .094

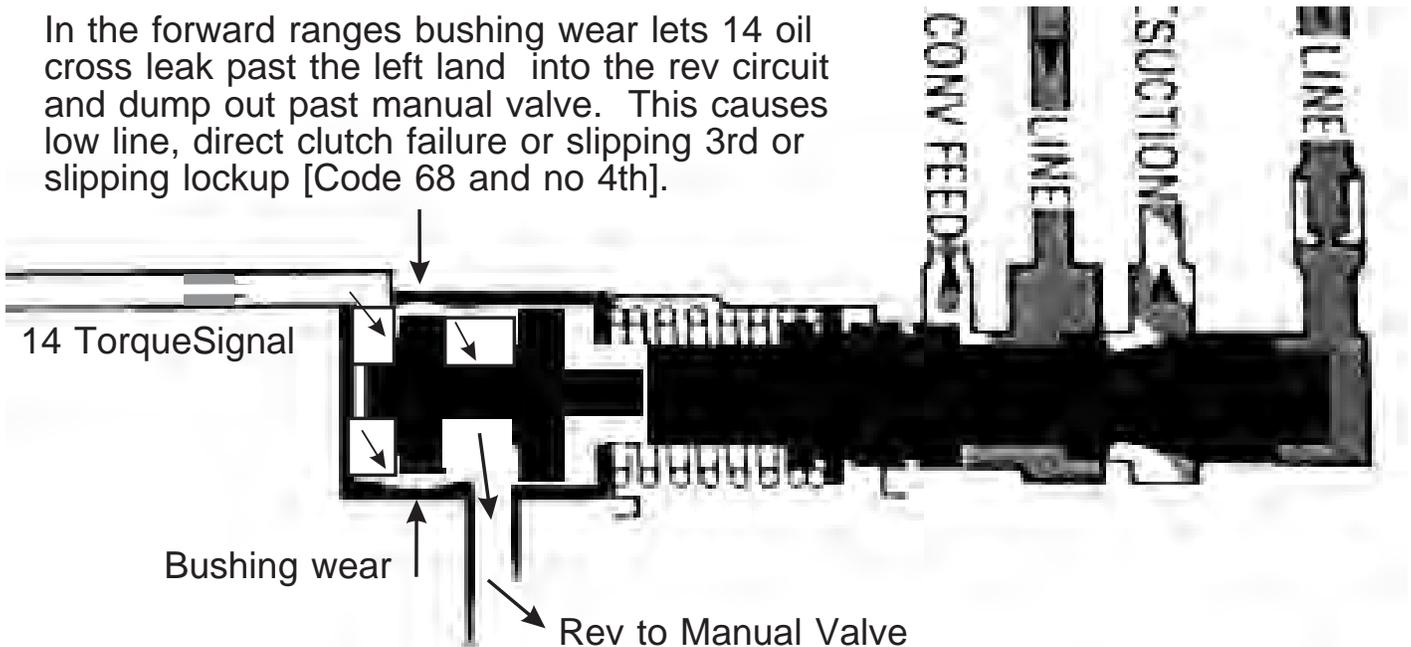
In the forward ranges bushing wear lets 14 oil cross leak past the left land into the rev circuit and dump out past manual valve. This causes low line, direct clutch failure or slipping 3rd or slipping lockup [Code 68 and no 4th].

Original boost valve tilts and the sharp narrow lands wears the boost bushing.

A temporary solution is to replace the bushing. The lasting solution is to install the the boost valve furnished in the Shift Kit®.

New wide double land valve will prevent wear and works in a new area to save worn bushing.

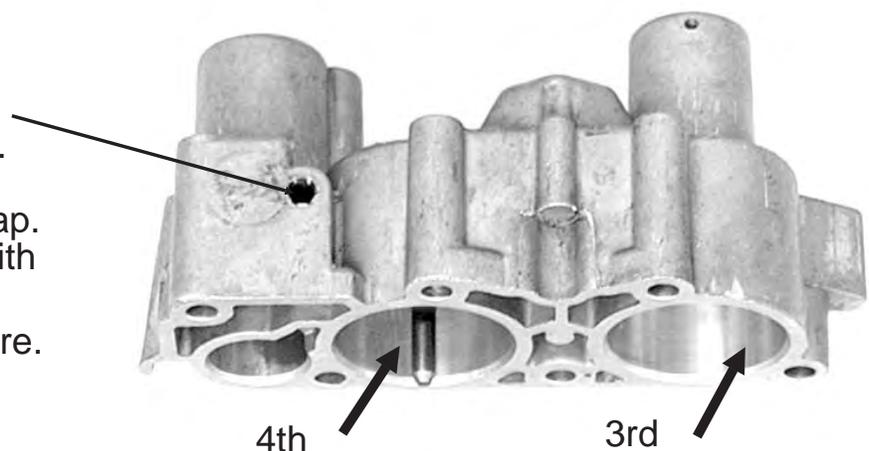
Open hole = low line pressure.

Some scratches in 4th and 3rd accm bores is normal. But if the piston has dug into the side of bore more than a couple thousandths, replace the housing. **Remember: Plug hole in new body.**

Be sure this hole is plugged.  
If hole is open tap it 3 to 4  
threads deep with 5/16-20 tap.  
Screw 350 pan bolt into it with  
sealer and cut it off flush.
