# 4L80E *2nd Printing*

## ***Before & After Service Complaints***

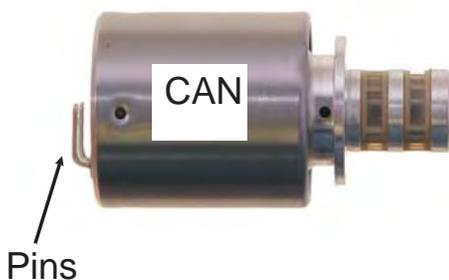
1st type: SHINY can—GERMANY

If trans has 1st type, replace it with 2nd type. 1st type has SHINY can and “GERMANY”.

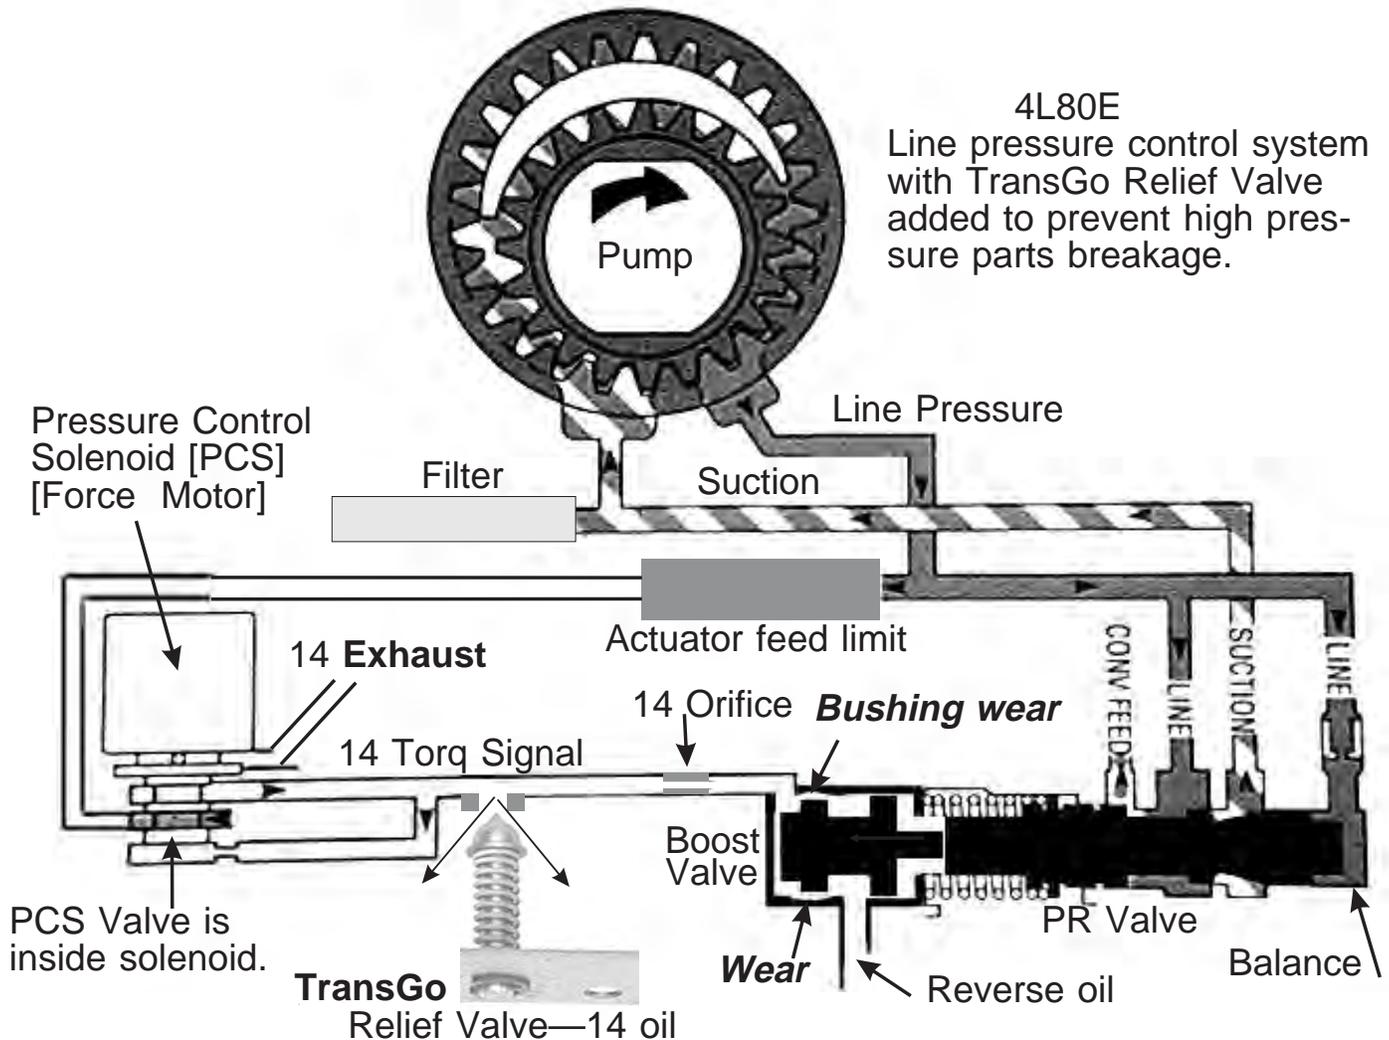
4L80E  
Line pressure control system  
with TransGo Relief Valve  
added to prevent high pressure  
parts breakage.

Reverse oil [which is line pressure] enters boost valve between the lands. The inboard land is larger, so the boost valve moves to the right against the PR valve to increase pressure. Rev pressure cross leaks leftward past the clearance in left land of boost valve and enters 14 circuit which forces the boost valve rightward causing pressure to skyrocket in the following situations:

- Volume of cross leak exceeds 14 orifice in separator plate. [Uh oh]
- Cross leak exceeds PCS valve exhaust. [Even slight wear/leak causes this.]
- Valve in solenoid sticks closed or midway. [Very common occurrence.]
- Valve in solenoid sticks open. [Rev is then 450psi instead of 270 to 370]
- No current to solenoid even momentarily for any reason. [450psi plus Rev.]

***In all of above conditions the added TransGo relief valve opens, and limits reverse pressure to prox 370 psi, which prevents parts breakage.***

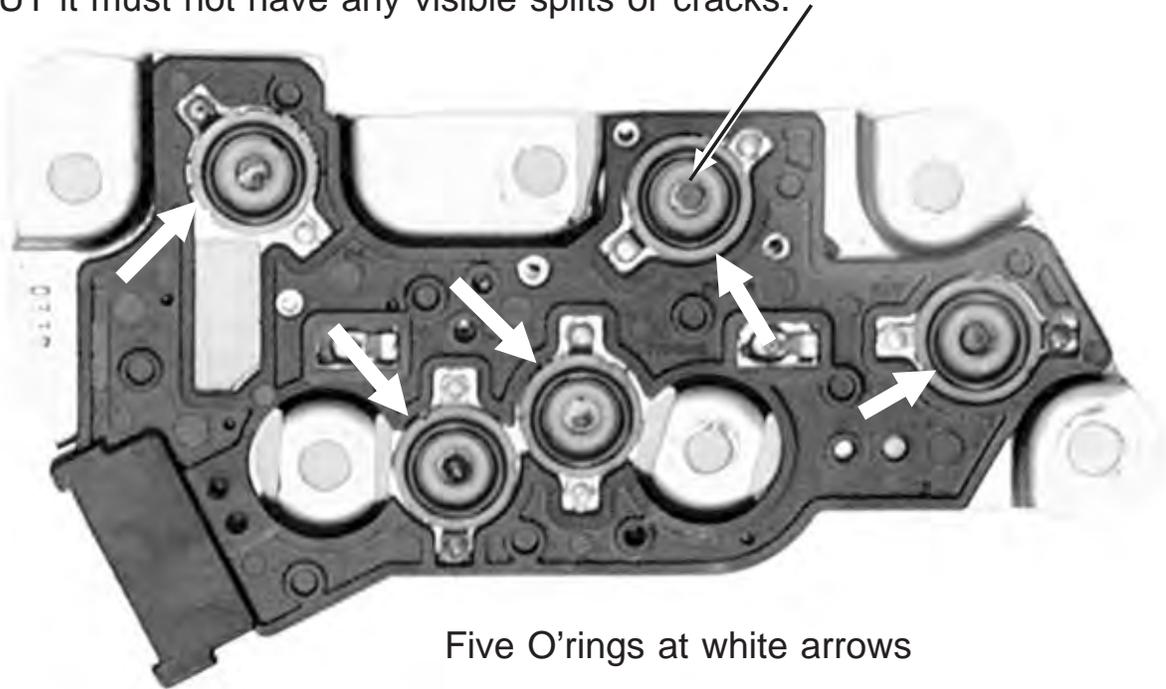
Look at plastic in the middle of each switch. It is OK for it to be wrinkled or look ugly, BUT it must not have any visible splits or cracks.

Five O'rings at white arrows

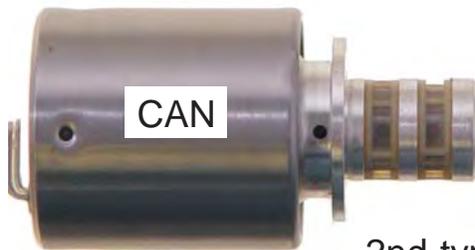
1st type: SHINY can—GERMANY

If trans has 1st type, replace it with 2nd type.  
1st type has SHINY can and says, "GERMANY"

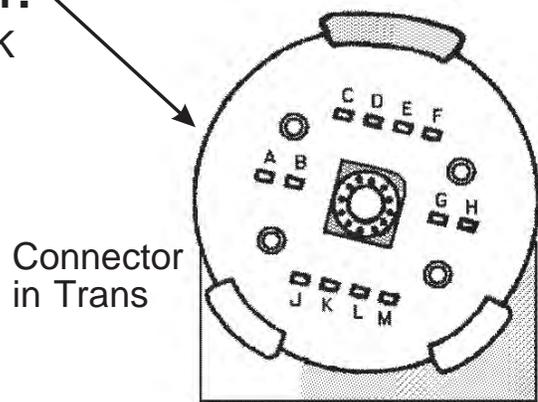
**1st design connector**

Has center attaching screw

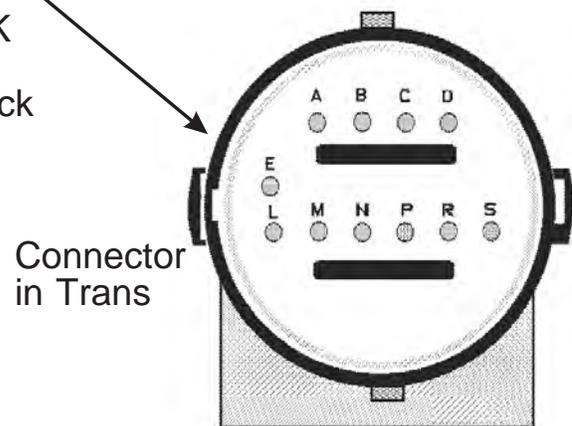
## 2nd design connector

Snaps on, has no screw.

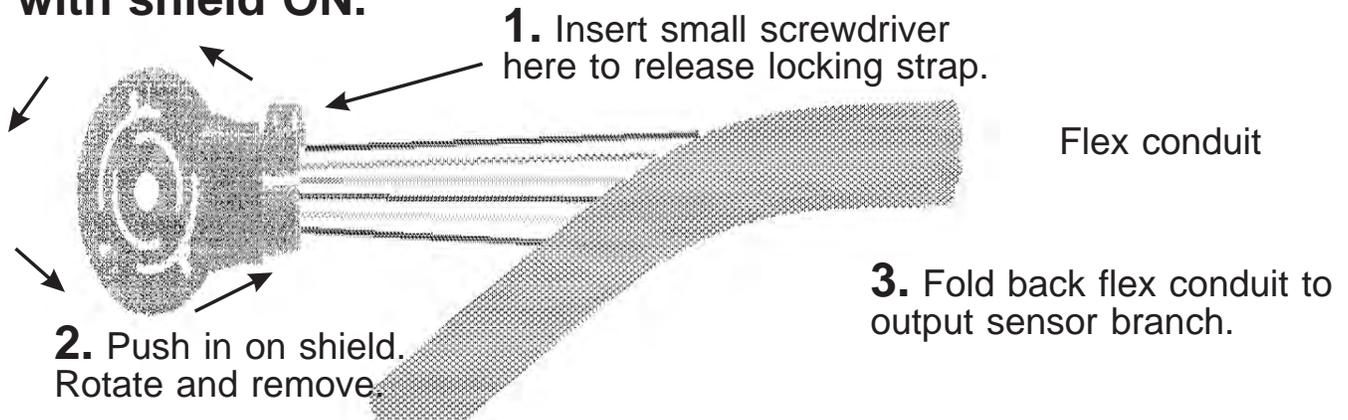
## 1st type connector with shield ON.

**Complaints:** Oil leak to outside connector—2nd gear only and high line [Fail Safe Mode]—Lock tabs or wires broken to the solenoids and switches. Crazy, shifts—neutral and
